Roof Assessment and Proposed Solution

VA Medical Center - Durham - Durham, NC

Prepared On: 06/03/2013

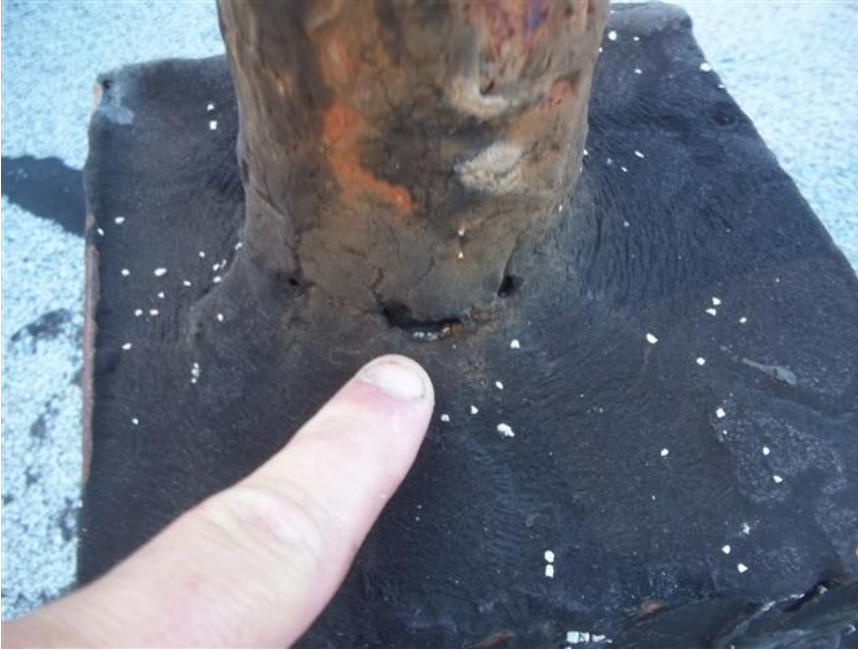
Caption: (All) Pipe Flashing Failure

Accessories-(All) Pipe Flashing Failure

Flashing is failing due to ultra violet exposure, building movement and expansion and contraction of building components.

Failing flashings allow moisture into the roof system. Moisture in the roof accelerates the failure of the roof system, insulation and decking.

- (All) Wall Flashing Failure - Allows moisture that results in premature membrane, insulation and decking deterioration. (see photo)
- (All) Pipe Flashing Failure - Allows moisture that results in premature membrane, insulation and decking deterioration. (see photo)

Flashing needs to be restored to ensure a watertight condition.

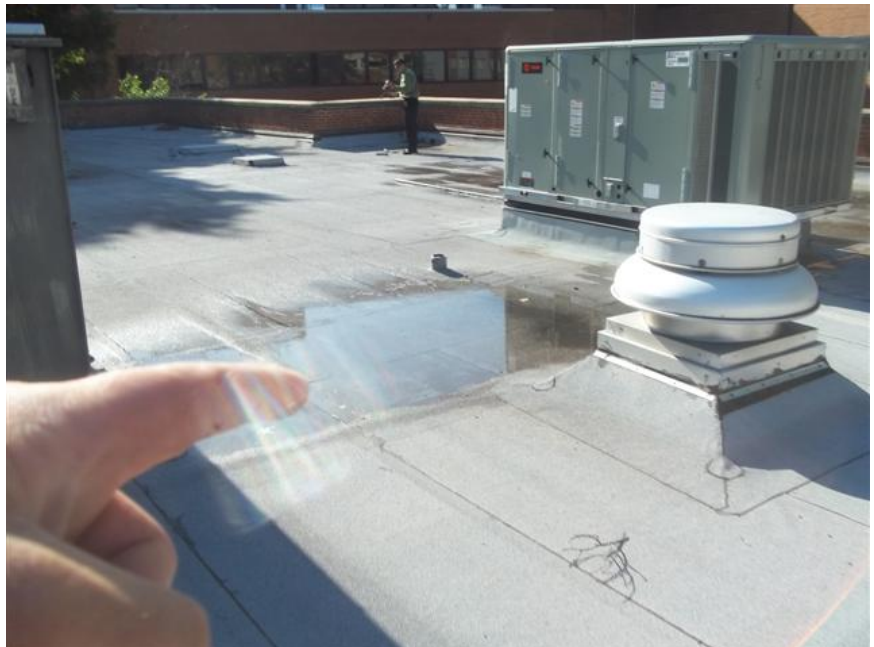
Caption: (All) Standing Water

Field of the roof-(All) Standing Water

Inadequate slope to drain, missing crickets and saddles, and deck deflection are common causes.

Standing water places an additional weight load on structural members and decking. Many roofing materials are weakened or damaged by prolonged exposure to standing water.

- (BUR/Mod-Bit) "Ridging" of Cap Sheet - Will lead to problems such as punctures, tears, internal leaks and premature system failure. (see photo)
- (All) Standing Water - Standing water places a strain on the waterproofing membrane, structural members and decking. (see photo)

Drainage: The roof currently experiences standing water. Remediating measures such as the use of additional drains, gutters, downspouts, diverters, or crickets is suggested.

Install supplemental roof drains or tapered insulation in standing water areas to improve drainage.

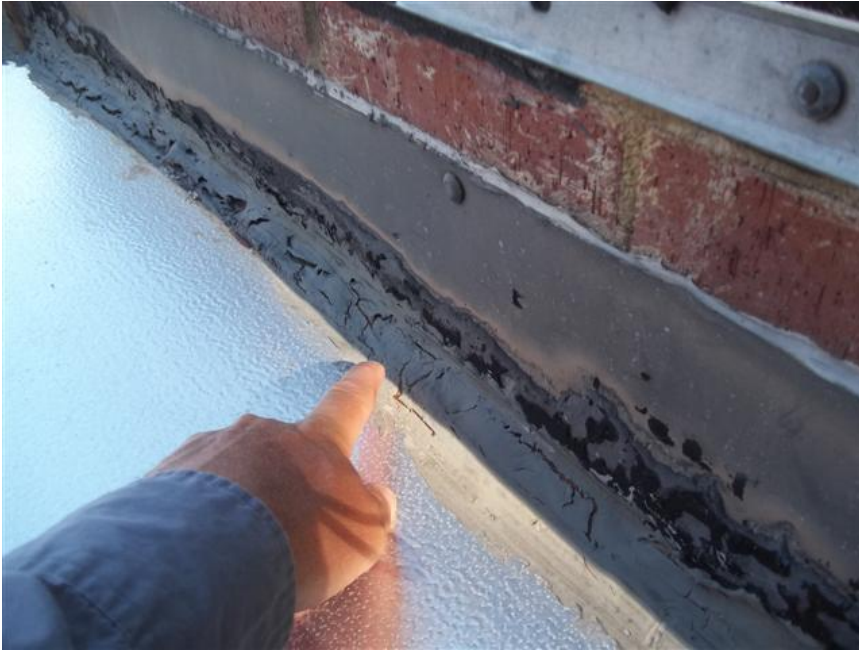
Caption: (All) Wall Flashing Failure

Accessories-(All) Wall Flashing Failure

Flashing is failing due to ultra violet exposure, building movement and expansion and contraction of building components.

Failing flashings allow moisture into the roof system. Moisture in the roof accelerates the failure of the roof system, insulation and decking.

Flashing needs to be restored to ensure a watertight condition.

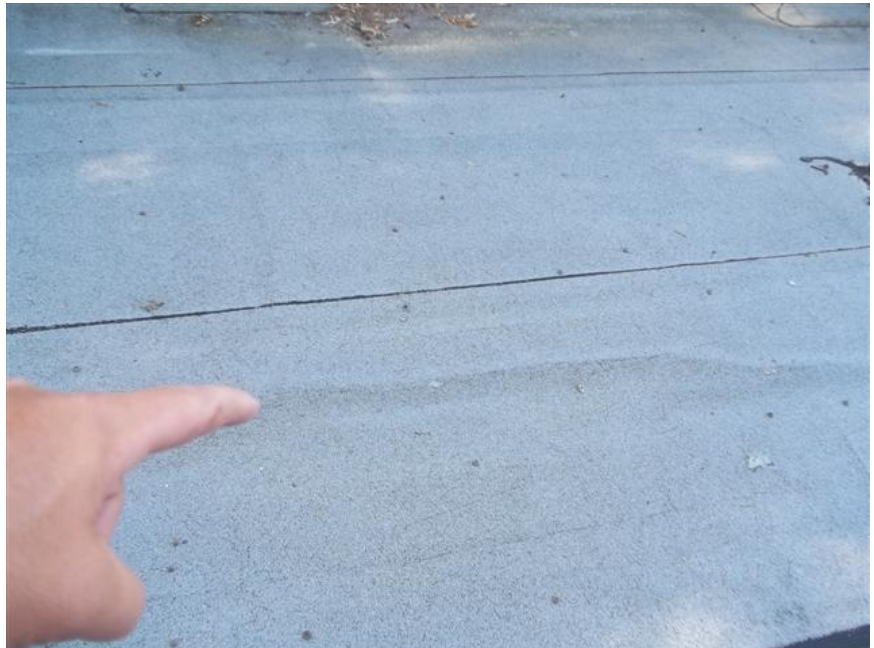
Caption: (BUR/Mod-Bit) "Ridging" of Cap Sheet

Field of the roof-(BUR/Mod-Bit) "Ridging" of Cap Sheet

Material shrinkage, building movement, improper installation or poor workmanship.

This condition can allow moisture entry into the building and roof system, causing damage to the building contents, and deterioration of the insulation, decking and the roof system.

Keep this area closely monitored. If leaking exists, remove the wrinkled area and repair with compatible materials.

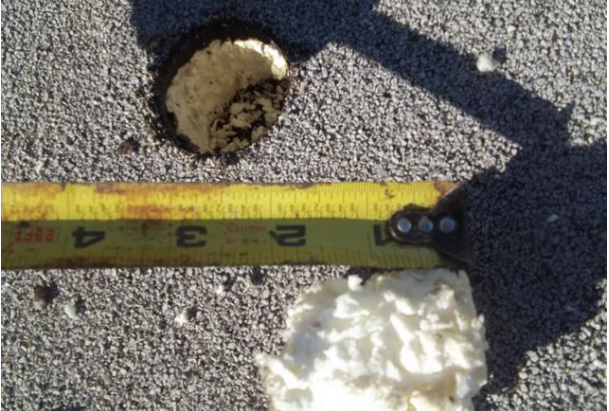
Section: Bldg 6	Sq. Footage: 6,905	Leaks: Multiple

Roof Condition Summary: We strive to provide our customers with comprehensive information as to their overall roof condition and life expectancy. The roof is in poor condition. As a short-term measure, repairs are needed. It is also suggested that near future roofing work be budgeted.

Membrane: The field of the roof is starting to show visual symptoms of aging. There are noted irregularities in the roof surface. Repairs to the membrane in the identified areas and the institution of a comprehensive preventive maintenance program should be considered.

Details: There are signs that the details of the roof are in need of attention. Items such as caulking along termination points, filling pitch pans, and minor repairs to flashing need to be done. A comprehensive preventive maintenance program is suggested at this point to insure that the roof continues to perform at acceptable levels.

Insulation: The insulation in the roof assembly appears to be in fine condition.

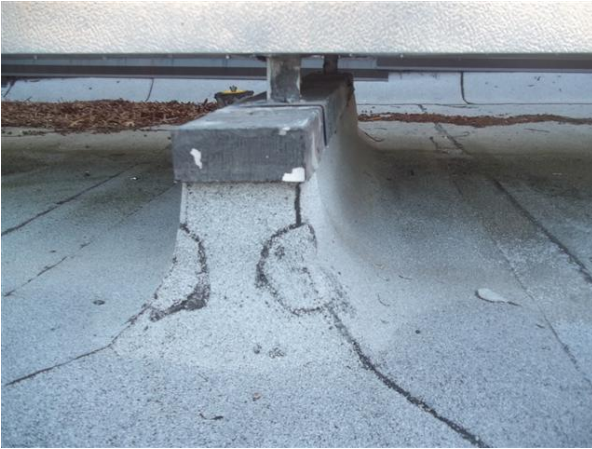
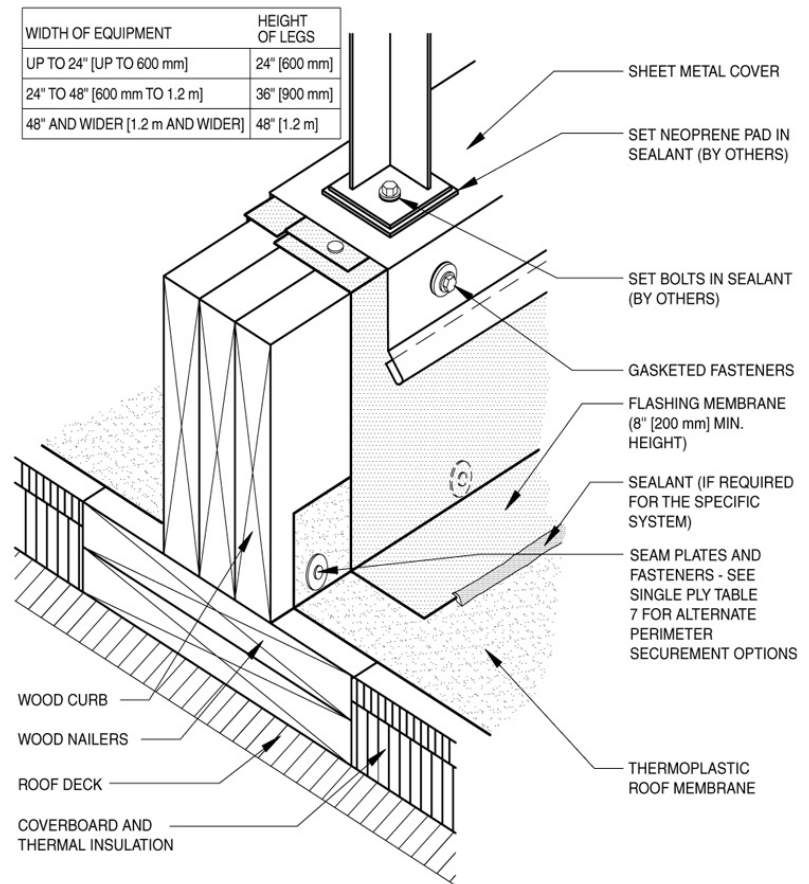
Caption: Equipment Support Curb

WIDTH OF EQUIPMENT	HEIGHT OF LEGS
UP TO 24" [UP TO 600 mm]	24" [600 mm]
24" TO 48" [600 mm TO 1.2 m]	36" [900 mm]
48" AND WIDER [1.2 m AND WIDER]	48" [1.2 m]

EQUIPMENT SUPPORT CURB

Furnish and install at the base of the unit 2 3/8" round seam plates to the field membrane. Adhere a second piece of thermoplastic membrane to the curb with bonding adhesive and install prefabricated universal corners for reinforcement.

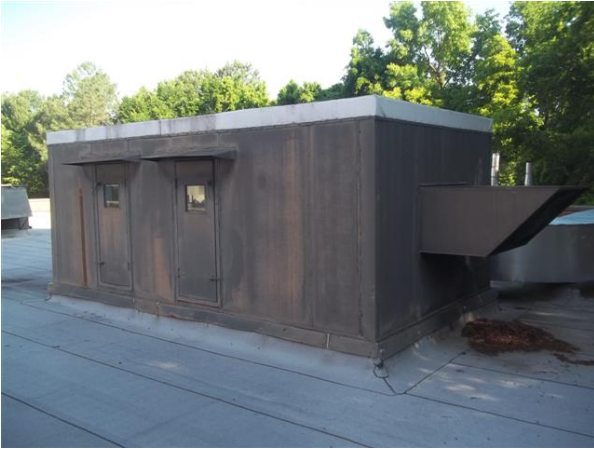
Section: Bldg 6
Area: Construction
Caption: Raised Curb Detail for Rooftop Air Handling Units and Ducts (Prefabricated Metal Curb)

RAISED CURB DETAIL FOR ROOFTOP AIR HANDLING UNITS AND DUCTS (PREFABRICATED METAL CURB)

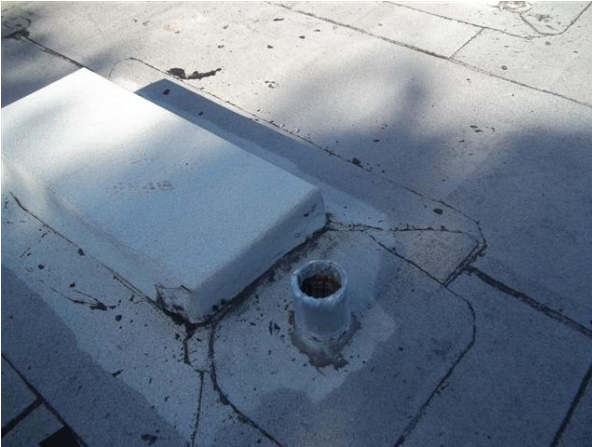
Section: Bldg 6
Area: Construction
Caption: Raised Curb Detail for Rooftop Air Handling Units and Ducts (Prefabricated Metal Curb)

**RAISED CURB DETAIL FOR ROOFTOP AIR
HANDLING UNITS AND DUCTS
(PREFABRICATED METAL CURB)**

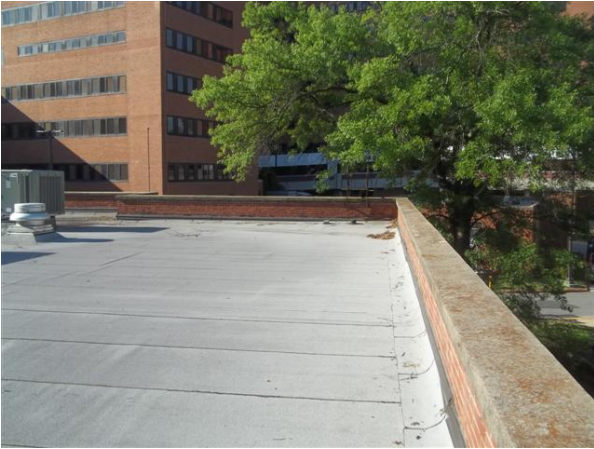
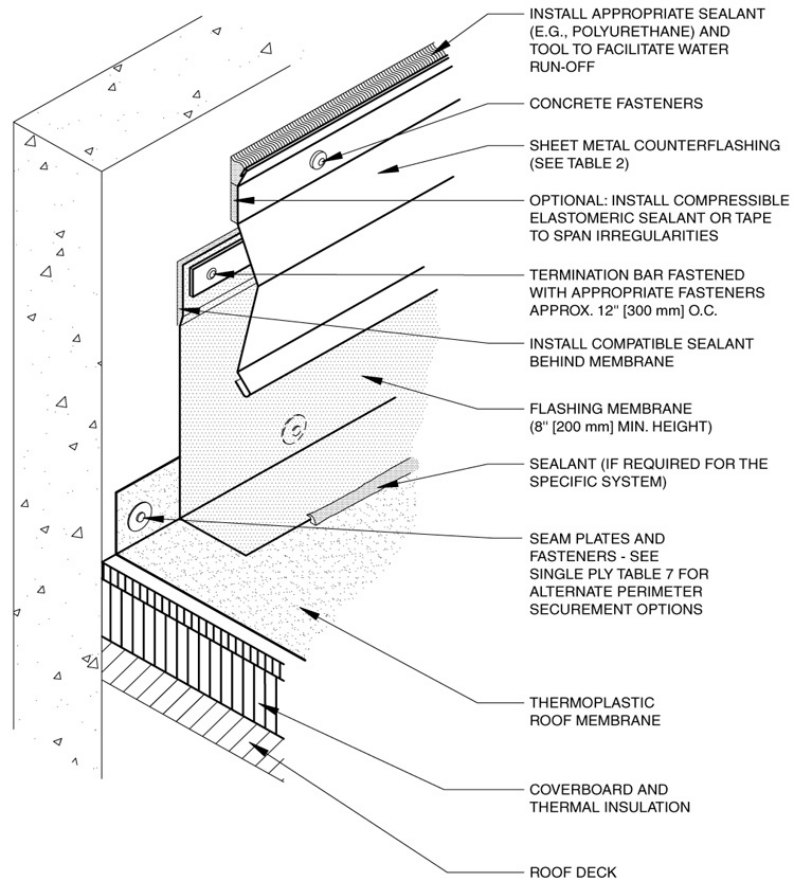
Section: Bldg 6
Area: Construction
Caption: Surface-Mount Counterflashing for Concrete Walls

**SURFACE-MOUNTED COUNTERFLASHING
FOR CONCRETE WALLS**

Furnish and install 2 3/8" round seam plates or 1" wide polymer batten strip to the field sheet at the base of the wall. A second piece of membrane will be adhered to the wall, welded to the field sheet and terminated with an aluminum bar.

Furnish and install aluminum termination bar at the top edge of the flashing membrane on interior/exterior walls.

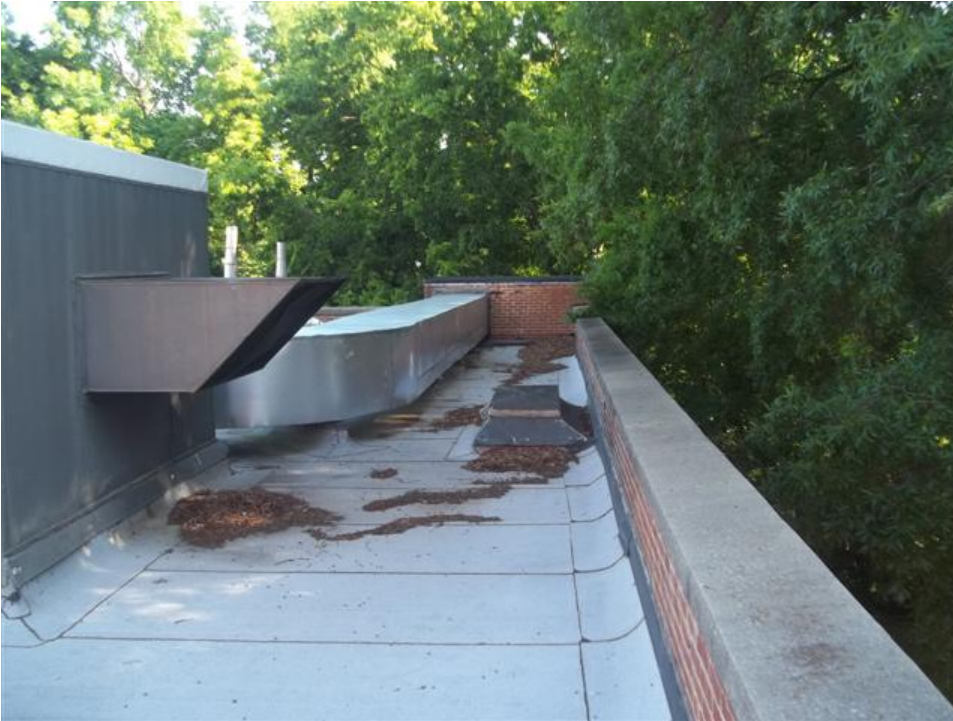
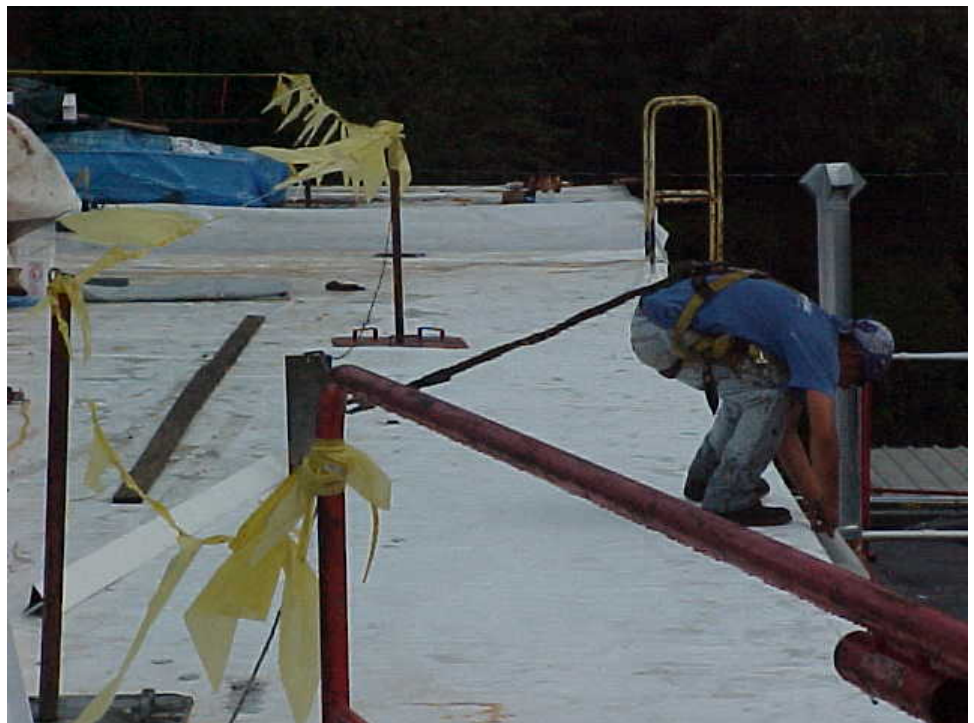
Area: Safety

Flags & MSS - Edge MSS

Exposed Edges - Fall Hazard

Centimark employee could fall off the edge resulting in serious injury or death.

Run a 3/8 inch cable, 7ft back from edge, to prevent employee, wearing a 6ft lanyard, from reaching the fall hazard but still allowing work to be done on the edge.
